## Historic flood marks and flood frequency analysis of the Danube River at Bratislava, Slovakia

**Abstract:** In this paper we focused on the history of floods and extreme flood frequency analysis of the upper Danube River at Bratislava. Firstly, we briefly describe the flood marks found on the Danube River in the region of Bratislava, Slovakia, and provide an account of the floods' consequences. Secondly, we analyzed the annual maximum discharge series for the period 1876–2012, including the most recent flood of June 2013. Thirdly, we compare the values of  $T$ -year design discharge computed with and without incorporating the historic floods (floods of the years 1501, 1682, and 1787 into the 138-year series of annual discharge peaks). There are unfortunately only a few historic flood marks preserved in Bratislava, but there are very important and old marks in neighbouring Hainburg and other Austrian cities upstream to Passau. The calculated  $T$ -year maximum discharge of the Danube at Bratislava for the period 1876–2010 without and with historic flood values have been compared. Our analysis showed that without incorporating the historic floods from the years 1501, 1682, and 17

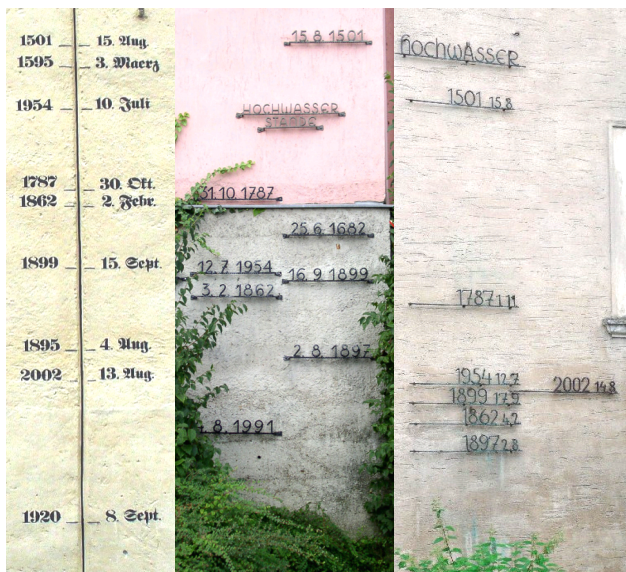
Fig. 2. Flood marks at Passau, Ybbs, and Melk (photo: Miklanek and Danecek, 2010).

The Danube floods which occurred after 1500 between Passau and Bratislava (Fig. 1) are generally well documented by flood marks. The flood marks are very important for estimation of the flood extent in comparison with recent high water levels, and for estimation of the extremality of the flood in historic time series. An example of such flood marks located in the vicinity of the river is shown in Fig. 2. As shown on the photographs, the highest flood after 1500, reliably and authentically marked on the Danube River stretch between Passau to Bratislava, occurred in August 1501. Kresser (1957) estimated the peak discharge at Linz was to be up to  $12,000 \text{ m}^3 \text{ s}^{-1}$ , and  $14,000 \text{ m}^3 \text{ s}^{-1}$  at Vienna. The aftermath of this "millennium flood" is reconstructed well in the historical annals: "carpenters

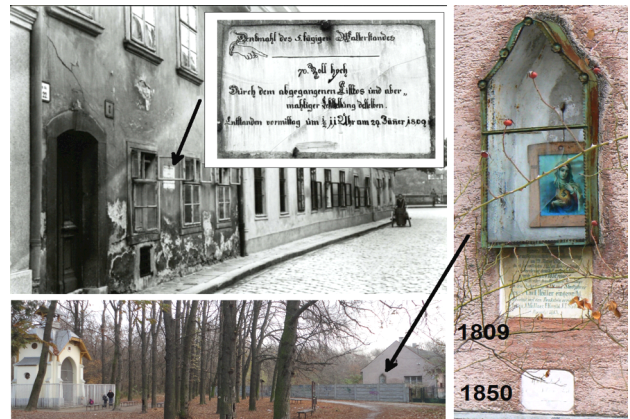
Fig. 4. Bratislava – Lodna St., 1809 flood mark (left up, photo from 1947 – Bratislava municipality archive); Petržalka city part. (down, right), old historic Kotesova hunting keeper’s lodge – 1809 and 1850 flood marks (photo: Pekarova, 2011).

molished 400 houses. Pisut (2002, 2009) carried out a concise but detailed analysis of the 1809 flood at Bratislava. In 1809 (January, 29), the Danube breached the right bank and flooded the Bratislava city part – Petržalka. Memorial flood mark on this flood can still be found in the flooded area (Fig. 3, point 1, Fig. 4). The most damaged parts on left bank of the Bratislava city were: Zuckermadel, Vydrica, (point 2), Gorkeho St., Jenesskeho St., and Laurinska St. (point 3), as well as Grösslingova St. A flood mark of this flood was located on building in the Lodna St. (point 4, Fig. 4). The flood mark of this flood inheres in Hainburg (Fig. 5).

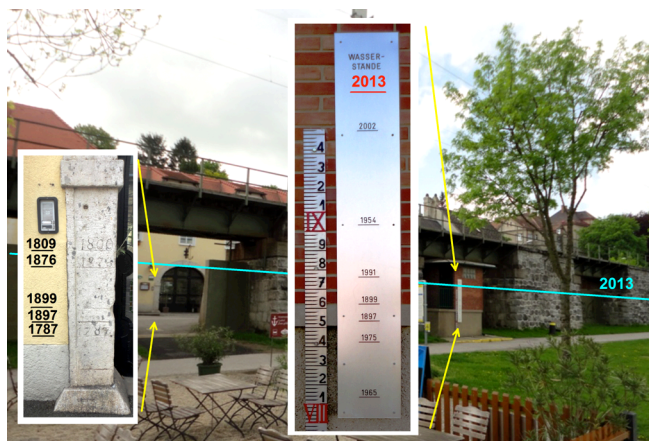
Fig. 5. Hainburg, Austria, water gauge station and historic flood marks (photo: Pekarova, 5. 5. 2013). Water stage June 6, 2013.

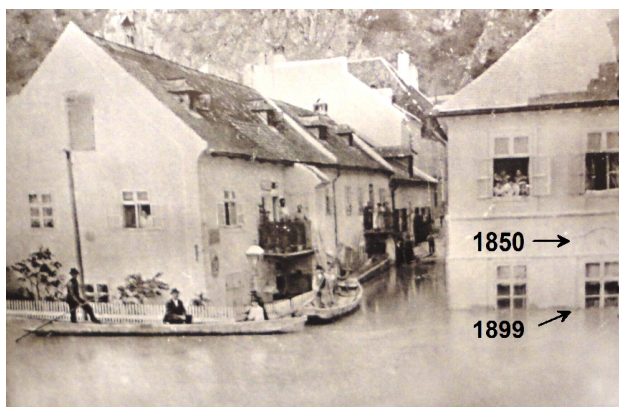
Fig. 6. Zuckermanel – Ballusova St. in 1899 – flood mark of the February 5<sup>th</sup>, 1850 flood, and water level of the 1899 flood (photo: adopted from the City Gallery of Bratislava).

During the flood of 1850 (February 5), the streets of Bratislava were under water again. Flood marks on the old buildings in the old town still show the height to which water reached during the past times. The water stage was then by nearly 200 cm higher than that of the 1954 flood. There are preserved three flood marks of this flood in the old city and one in Petržalka suburb (Fig. 4) below the mark of 1809. The flood mark of 1850 in the city quarter called Zuckermadel is indicated on the photograph of the 1899 flood (Fig. 6).

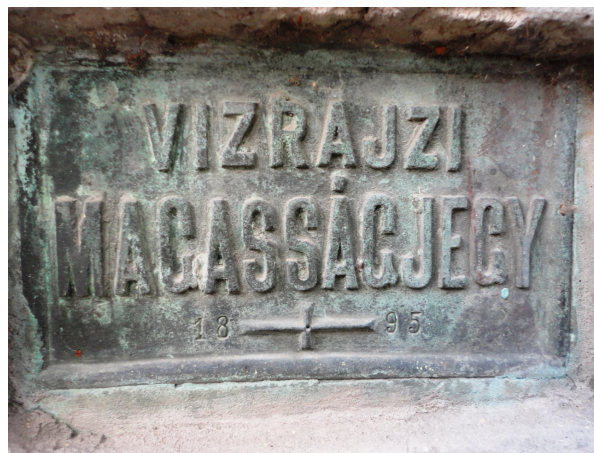
Fig. 7. The 1895 flood mark in the garden of Holy Trinity Church in Bratislava (photo: Miklanek, 2012).

We found a flood mark from 1895 in the garden of the Holy Trinity church in Bratislava (Fig. 7). This flood can be characterized as a spring flood, which we date to the end of April, 1895. No severe damages due to this flood, upstream of Bratislava, have been reported (Melo et al., 2012; Pekarova et al., 2012). The 1895 Danube flood manifested its magnitude particularly on the lower river reach and on its tributaries. The flood became even the most severe flood observed during the period of instrumented observations. Its discharge was exceeded only much later, in the year 2006.

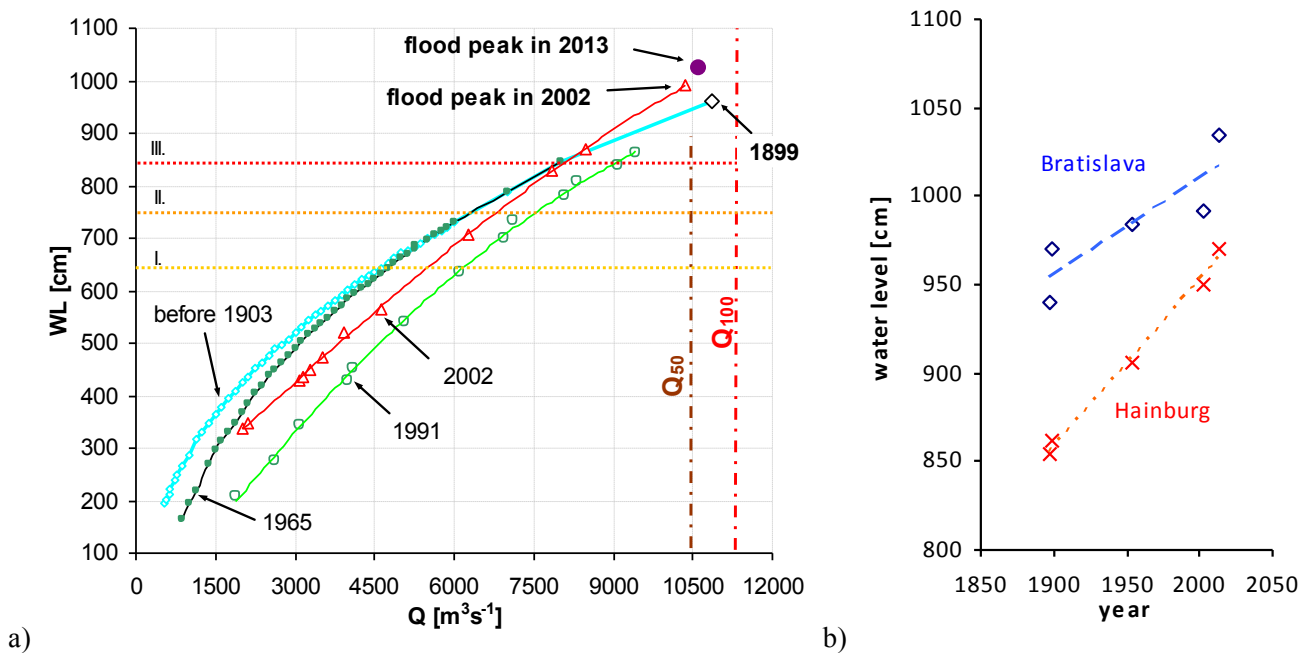
**Fig. 8a)** Changes of the Danube rating curve at Bratislava gauge (related to the present gauge zero water level WL); **b)** Water levels at Hainburg and Bratislava gauge for floods with peak discharge exceeding 10,000 m<sup>3</sup> s<sup>-1</sup> at Bratislava during the 1876–2013 period.

1876–1890 according to historic rating curve (Fig. 8a) (Pekarova et al., 2007a–b, 2008; Pekarova, 2009, 2010). Average daily discharge characteristics (1876–2010) are presented in Table 1.

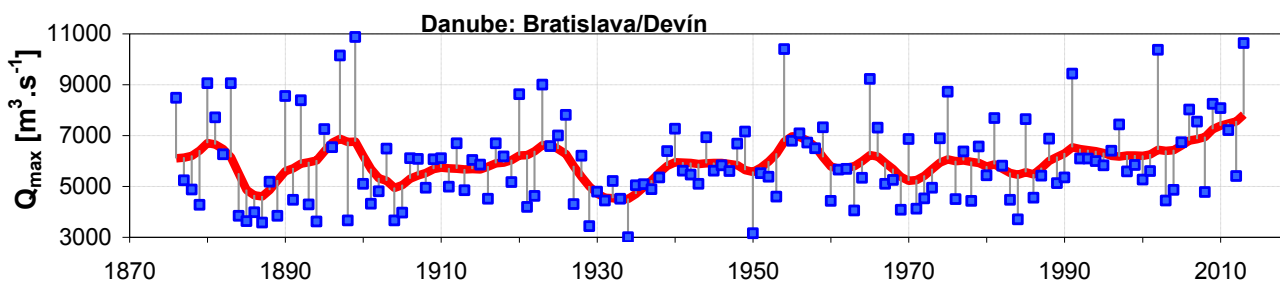
**Fig. 9.** Danube at Bratislava, instrumental period 1876–2013, annual maximum discharges (points) and annual discharge maxima 5-years moving averages (bold line).

In Table 2, there are statistically processed the maximum annual discharge at Bratislava for the period after 1876. This time series is depicted in Fig. 9. The greatest floods in this river section during the instrumental observation period occurred in last quarter of the 19th century (1876–1900). Five floods with peak discharge exceeding 10,000 m<sup>3</sup> s<sup>-1</sup> occurred during the 1876–2013 period: once in June (2013), July (1954) and September (1899), and twice in August (1897, 2002). This data correspond to the data contained in Blöschl et al. (2013). In Table 3 we compared the peak water levels at Hainburg and Bratislava gauge, and discharge during these floods. By comparing the water level and discharge in the years 1899 and 2013 one can see that water level rises in this river reach at the similar discharge (Fig. 8b, Fig. 10). The reasons of this discrepancy can be attributed either to the altering river bed due to gradual sedimentation and narrowing of the Danube channel at Bratislava.

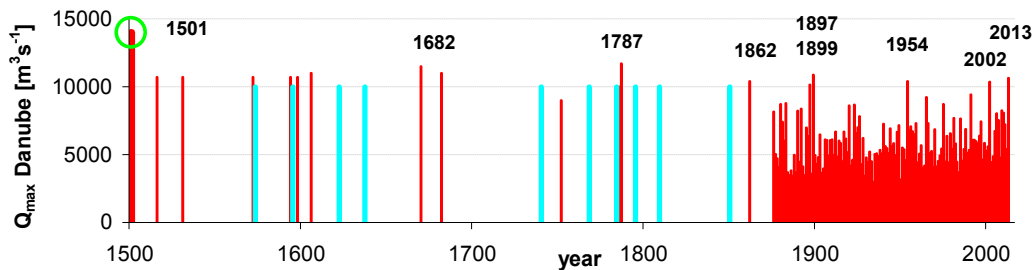
**Fig. 11.** Historic Danube floods in river section Kienstock – Bratislava since 1500 up to 1876 (dark columns – summer floods, light columns – winter floods); since 1876 – the observed annual peaks  $Q_{\max}$  at Bratislava station.

In general, severity of every flood, with respect to its peak flow, is expressed as the probability of its occurrence or exceedance (Blöschl and Merz, 2008). Based on the historical references, we set up a series of historically significant floods (since 1501) on the Danube upstream of Bratislava (Fig. 11). In this river section, there are about ten summer floods known to have occurred before 1876. We used the maximum discharge time series  $Q_{max}$  from the period of instrumented measurements

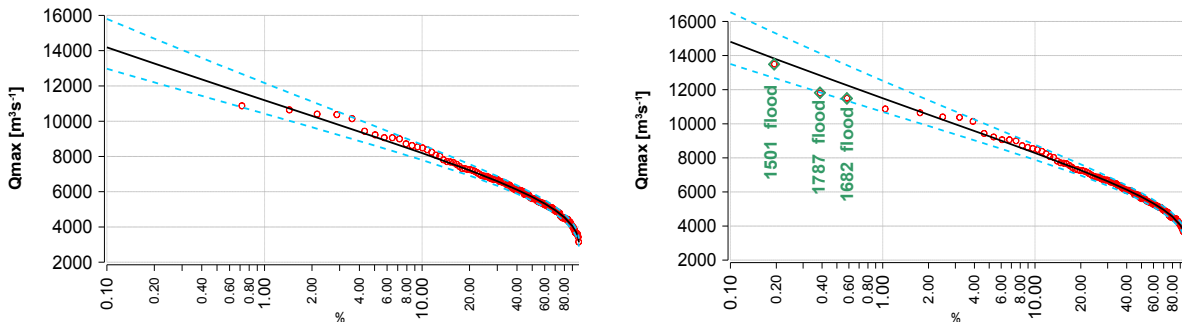
**Fig. 12.** Empirical and theoretical – log-Pearson type III distribution curve of the annual maximum discharge without and with historic floods, 5% and 95% confidence limits, Danube: Bratislava.

Firstly, we needed to choose the appropriate type of the theoretical probability distribution curve. We tested several models to achieve a good fit to the flood-discharge data. The choice of the distribution curves has substantial effect on the estimation of the  $T$ -year discharge, particularly for high return periods. For example, the 1000-year discharge according to log-normal distribution on the Danube River at Bratislava station is  $13,977 \text{ m}^3 \text{ s}^{-1}$ , and according to log-Pearson III. type distribution it is  $14,188 \text{ m}^3 \text{ s}^{-1}$ . We recommend the log-Pearson type III (LP3) distribution using in flood frequency investigations. In the next step, we included the historic floods from the years 1501, 1682, and 1787 into the 138-year series of annual discharge peaks (Fig. 12). The calculated  $T$ -year maximum discharge of the Danube at Bratislava for the period 1876–2013 without and with estimates of historic flood discharges are listed in Table 4a–b. A consistent increase in the  $T$ -year discharge can be seen when the three floods from the pre-instrumental period are included.

Our analysis showed that without incorporating the historic floods from the years 1501, 1682, and 1787 into the dataset of discharge data covering the instrumental period (1876–2013), the 1000-year discharge calculated only with data from the instrumented period is  $14,188 \text{ m}^3 \text{ s}^{-1}$  (from  $12,971 \text{ m}^3 \text{ s}^{-1}$  to  $15,801 \text{ m}^3 \text{ s}^{-1}$ ) compared to the 1000-year discharge of  $14,803 \text{ m}^3 \text{ s}^{-1}$  (from  $13,500 \text{ m}^3 \text{ s}^{-1}$  to  $16,533 \text{ m}^3 \text{ s}^{-1}$ ) when the three historical floods exceeding an arbitrarily chosen threshold of  $11,000 \text{ m}^3 \text{ s}^{-1}$  are included. In general, the  $T$ -year discharge is higher throughout the whole spectrum of  $T$ -year discharges (10, 20, 50, 100, 200, 500-year discharge) when the three historic floods are included. Based on our results, we subscribe to the conclusions of Gaal et al. (2010), i.e. incorporating historic floods into a time series of maximum annual discharge significantly improves estimation of low probability floods (500–1000-year floods).
