Barbara Zin

Institute of History of Architecture and Monument Preservation, Faculty of Architecture,
Cracow University of Technology

ON THE EUROPEAN CULTURAL HERITAGE ROUTE OF RESIDENCE OF THE RADZIWIŁLS – CASTLE IN OLYKA, VOLHYNIA

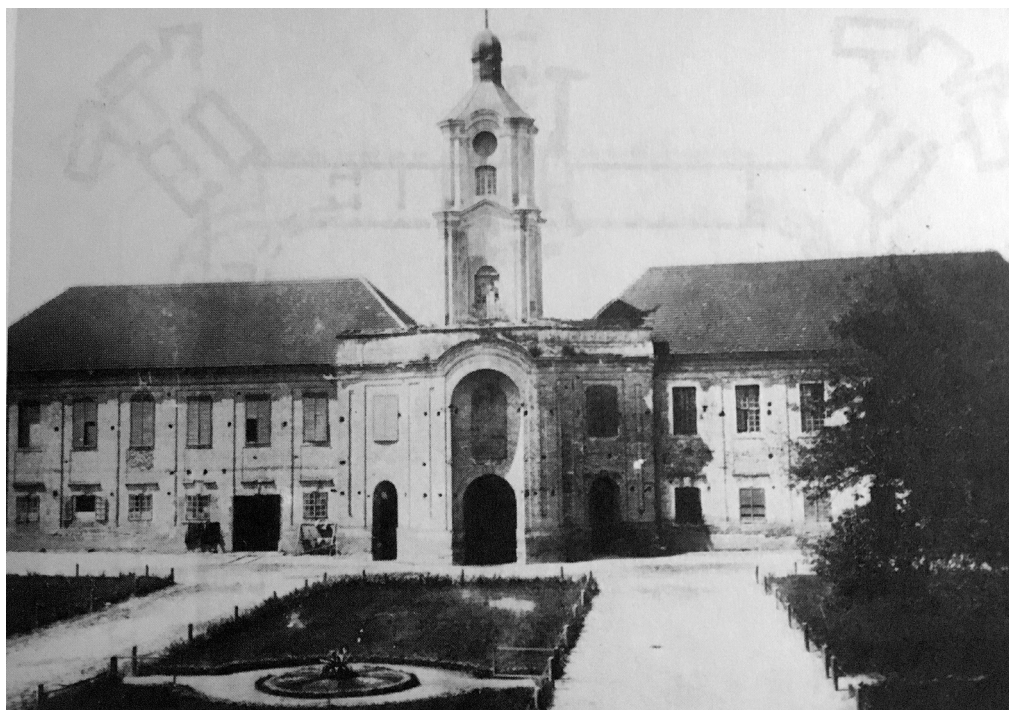
Fig. 3. Castle in Olyka, entrance gate facing the courtyard, before 1938 (source: [2])

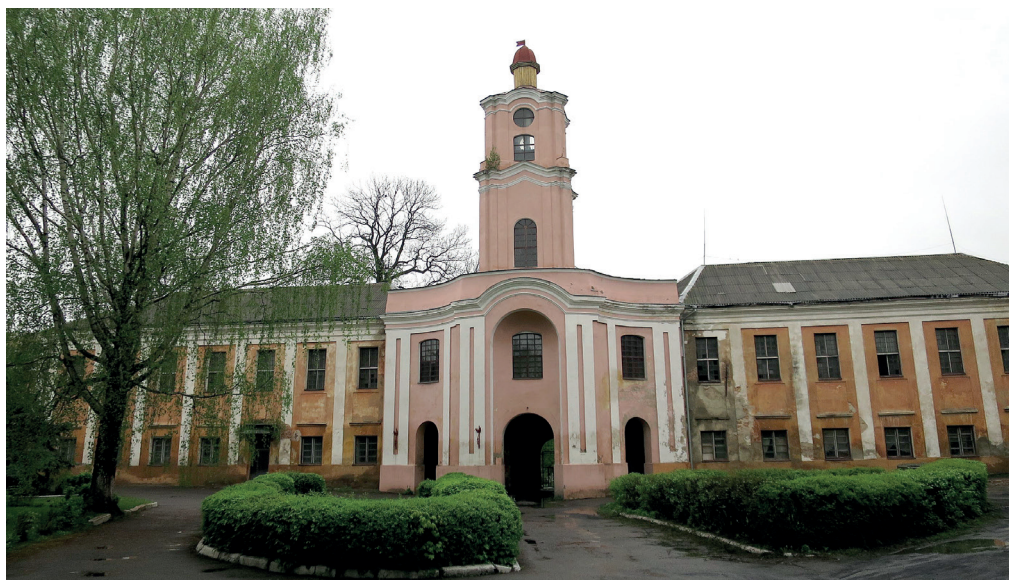
Fig. 4. Castle in Olyka, entrance gate, condition as of 2019 (photo by B. Zin)

progresses, and these processes result in the loss of authenticity of the palace complex with its entire historical legacy. Splintered and crumbling fragments of the bastion walls, leaking roofs of the edifice of the palace, collapsed ceilings, cracked and damp walls – this is a picture that depicts an annihilation of a centuries-long heritage. Current protective repairs carried out by the hospital staff are performed without any supervision of building and conservation services and unfortunately they are not capable of stopping the degradation of this valuable monument of architecture. Architectural heritage of the bygone centuries is slowly sinking into nothingness. The technical condition of the buildings calls for an immediate intervention of building and conservation services. For this purpose, it will be necessary to compile scientific documentation, opinions of experts on monument conservation and construction, as well as architectural studies. Developing in details each phase of transformations of the castle complex will allow to restore the today non-existent architectural design. The documentation compiled this way will constitute a foundation for developing an architectural and conservation project, aiming at the restoration of the former splendour of the residence. Regrettably, local authorities are not interested in the preservation of the cultural heritage of this magnate residence in Volhynia. A centuries-long architectural legacy of one family slowly falls into ruin.

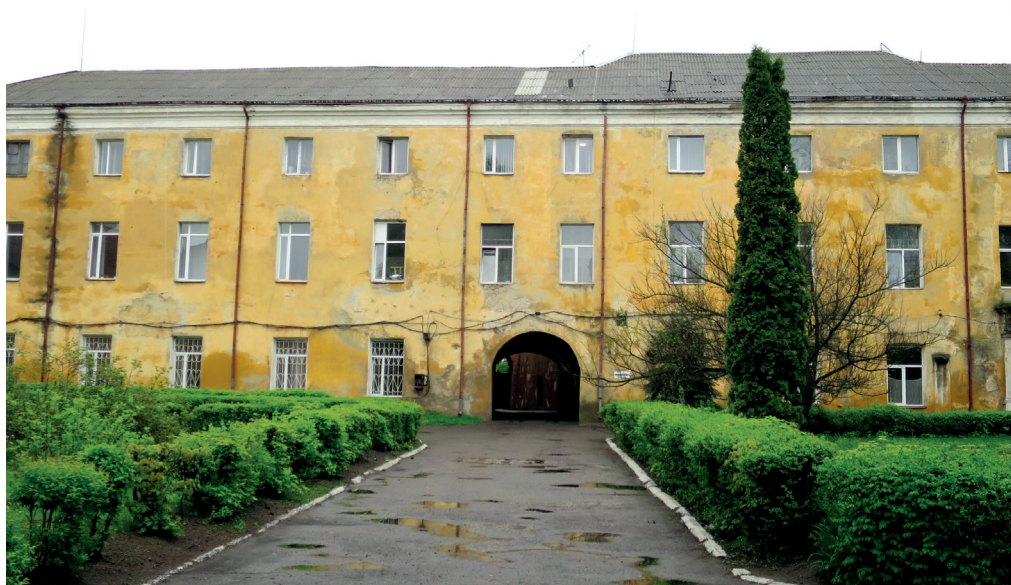
Fig. 6. Castle in Olyka, view of the wing of the palace facing the courtyard, condition as of 2019 (photo by B. Zin)

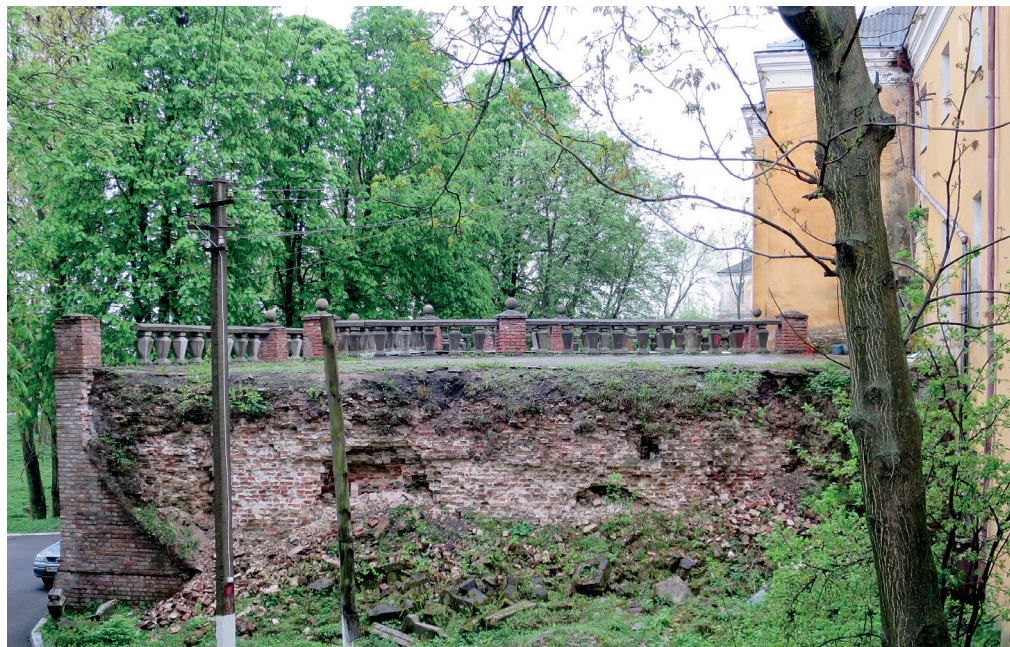
Fig. 7. Castle in Olyka, entrance gate facing the collegiate, condition as of 2019 (photo by B. Zin)

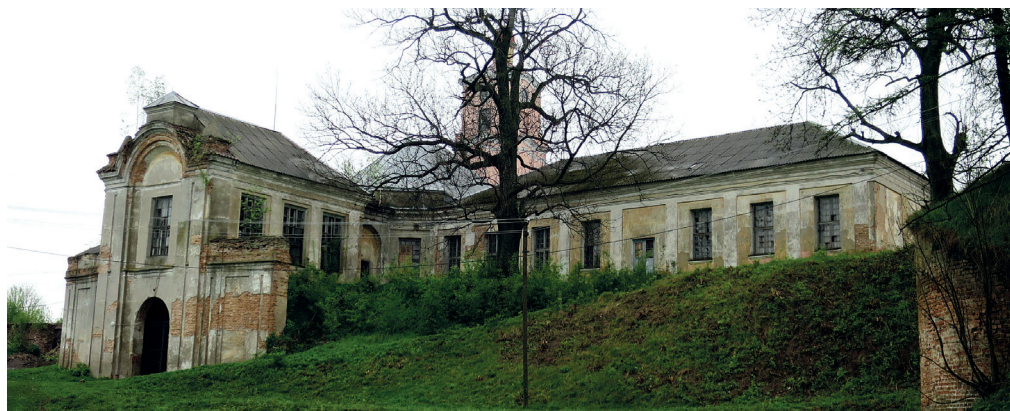
Fig. 8. Castle in Olyka, entrance gate facing Turczyn, condition as of 2019 (photo by B. Zin)
